Preliminary Risk Assessment Midland Road Former Landfill Site Scunthorpe North Lincolnshire

Final May 2012

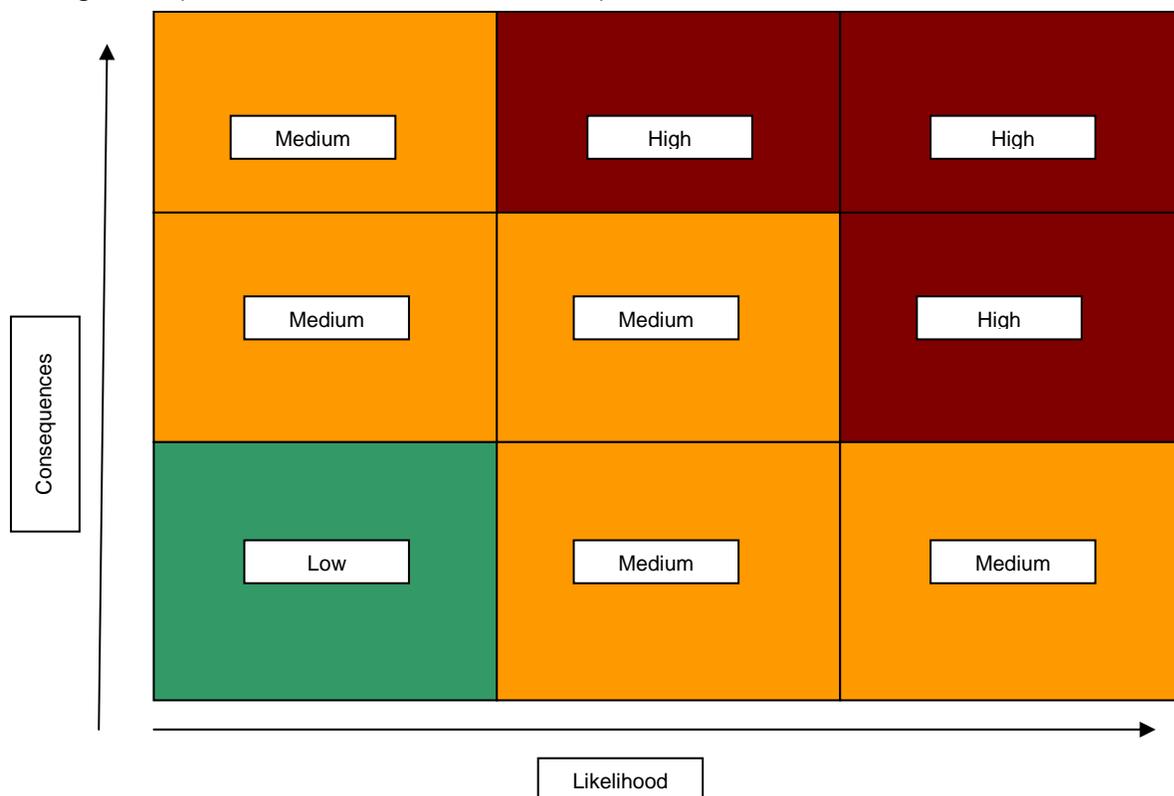
Figure 1 (Source Green leaves III 2011)

High risk pollutant linkages are considered to require urgent investigation and medium risked pollutant linkages are thought to require further investigation to clarify the predicted risk, whilst low risked pollutant linkages are thought not to require any further investigation.
